PROPERTY CONDITION REPORT

Property Name: Epic Brookside Apartments

Location: College Park, Georgia

Job # S7126/04

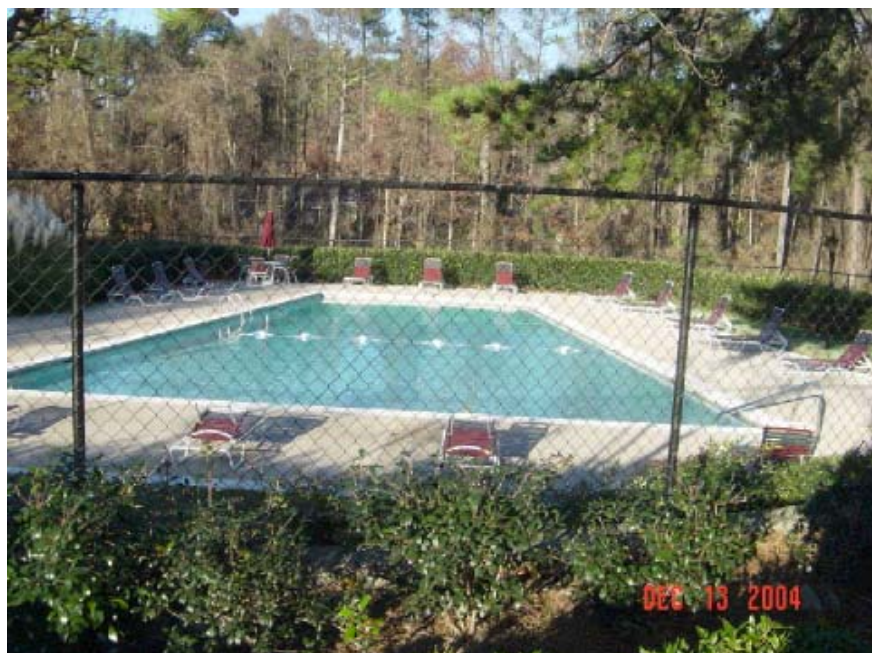
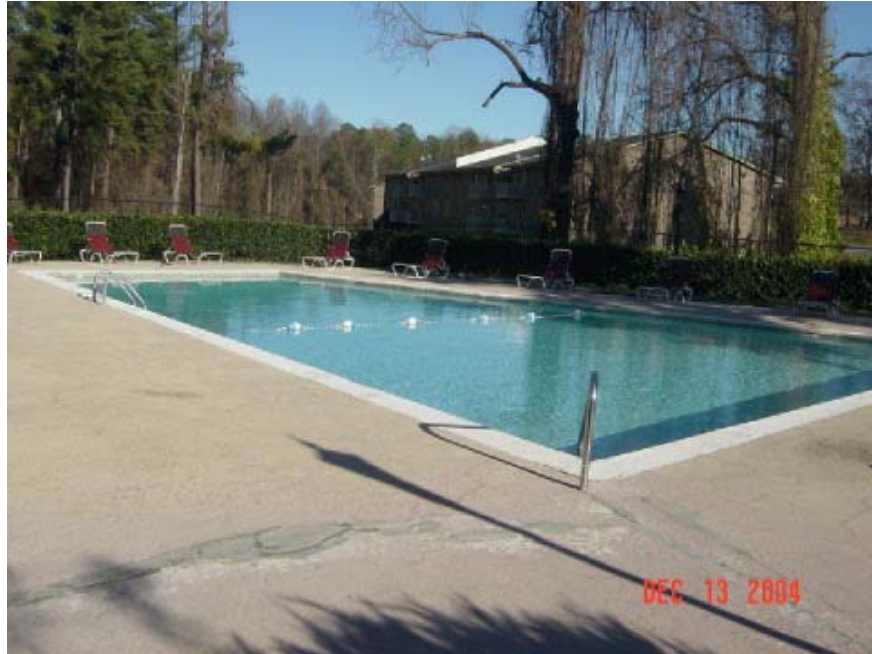
The leasing office/community building is in good overall condition (upgrades are a part of the proposed renovation), the pool will require renovation (decking, main drain installation), the laundry facilities are under contract with Coinmach

- 4 and 5. Swimming pool located adjacent to leasing office – deck repair and main drain addition required.

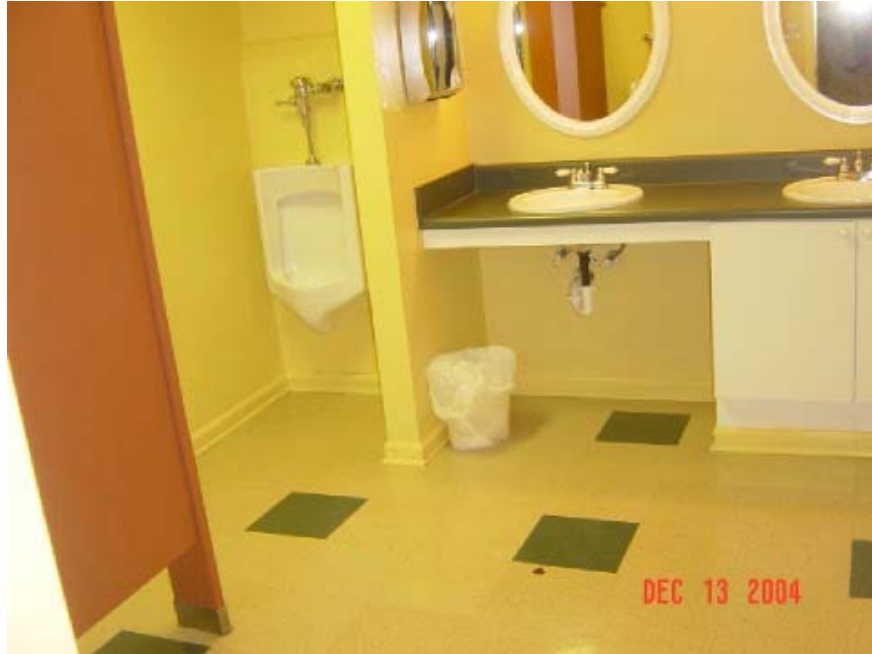
7. Bath in leasing/community building – not ADA compliant.

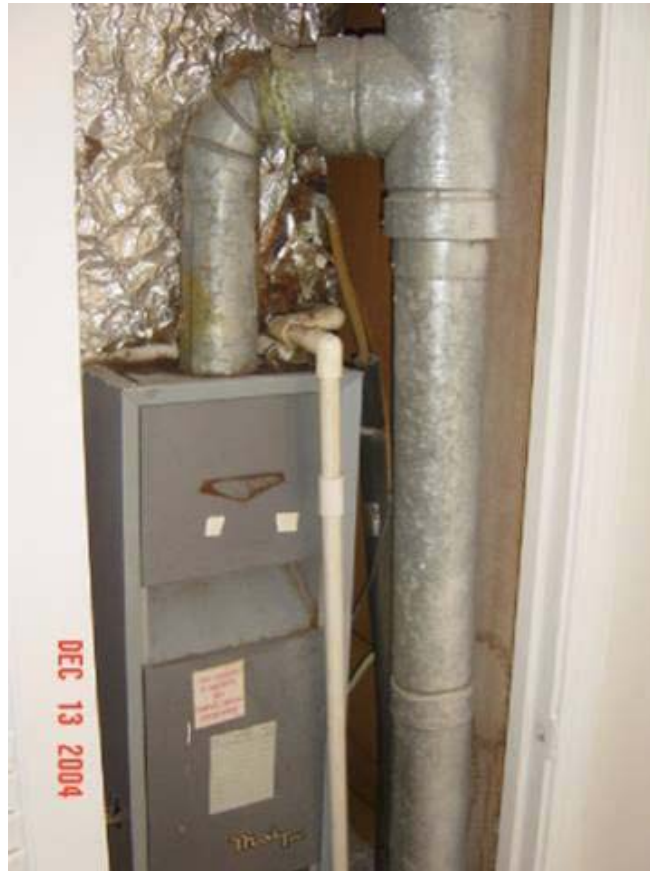
The plumbing system utilized is typical of this type of construction and is in overall good condition. Reportedly, gas fired commercial water heaters will be replaced with individual electric units as a part of the renovation.

26. Gas fired commercial domestic water heater and condition.

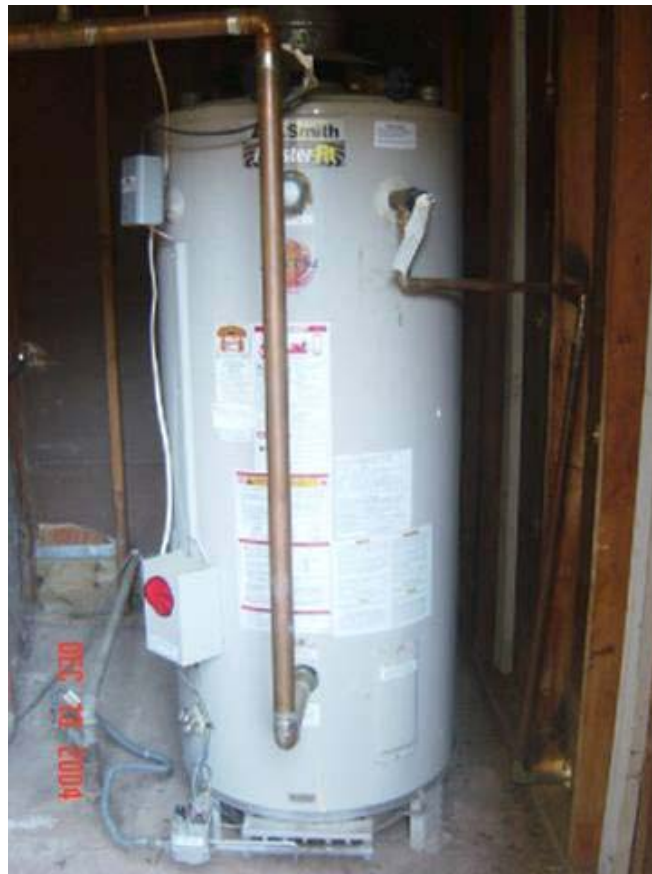
28. Gas fired commercial domestic water heater and condition.

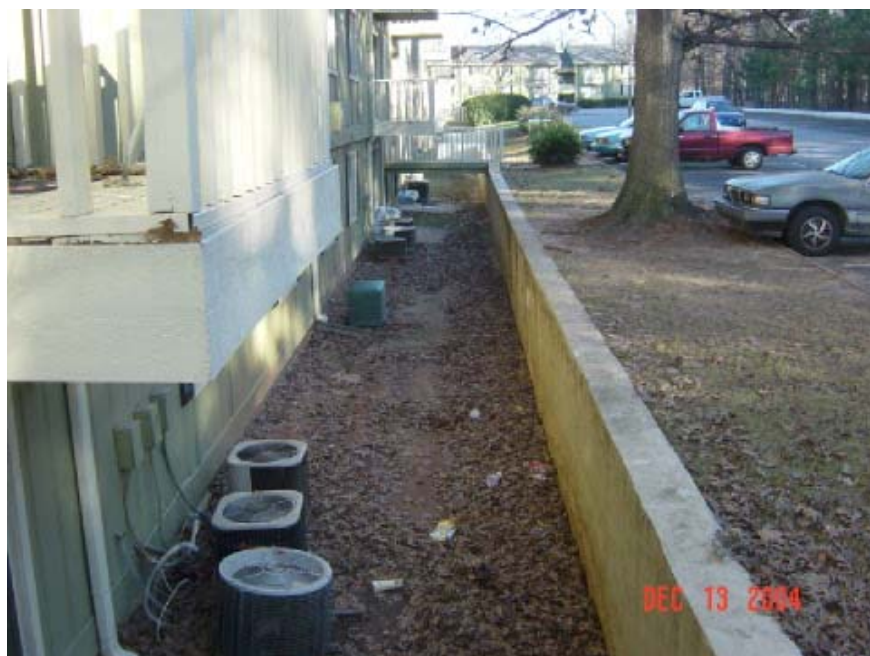
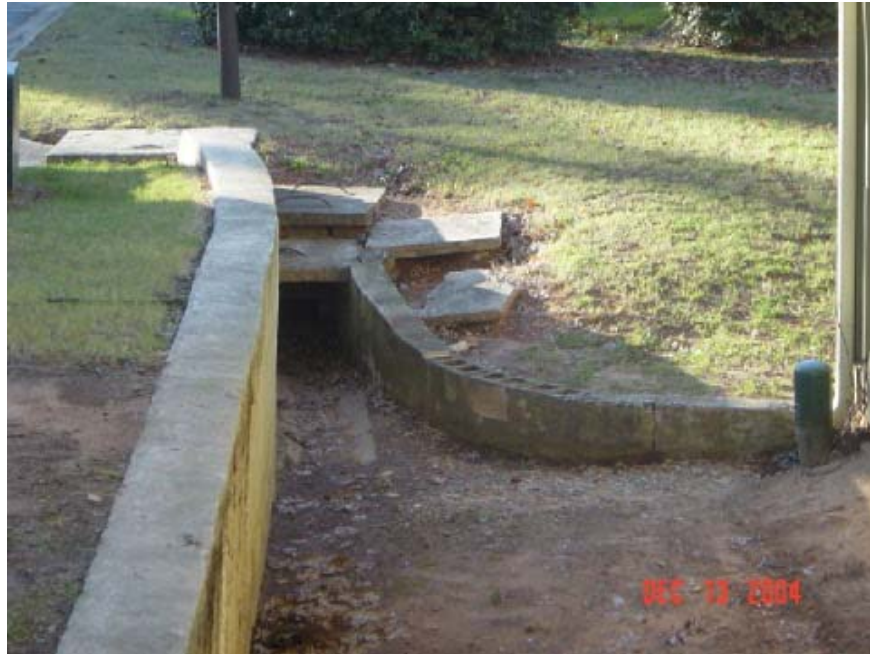
34 and 35. Retaining wall and area in need of landscape and drainage upgrade.

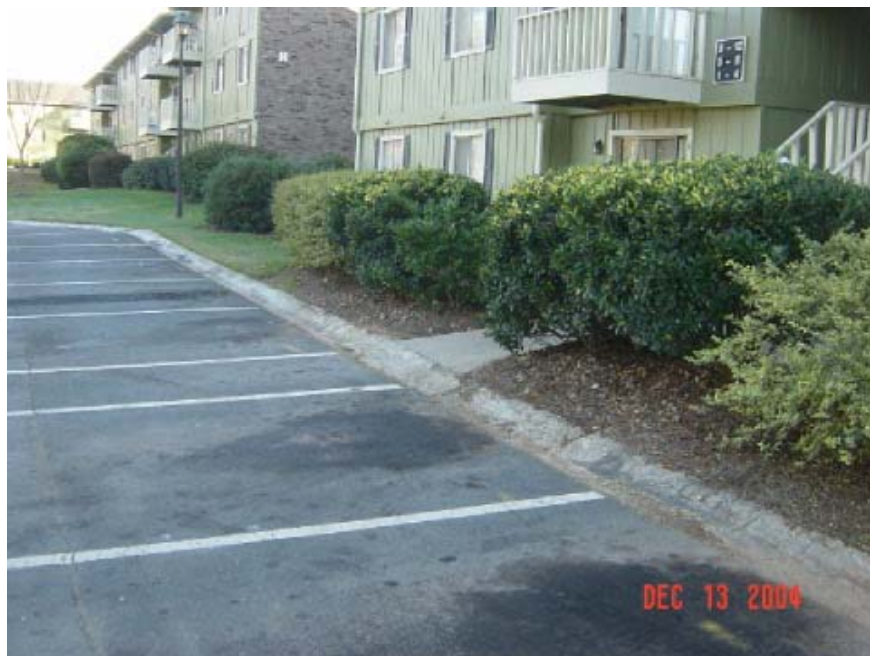
Overall, the condition of asphalt and concrete sidewalks is considered fair. Differential settlement was noted between adjoining sidewalk sections. We estimate approximately 900 square feet of required repair (liability due to trip hazard). These repairs can typically be accomplished for a square foot cost of \$8.00 (inclusive of removal).

36. Damaged concrete curb and walk area.

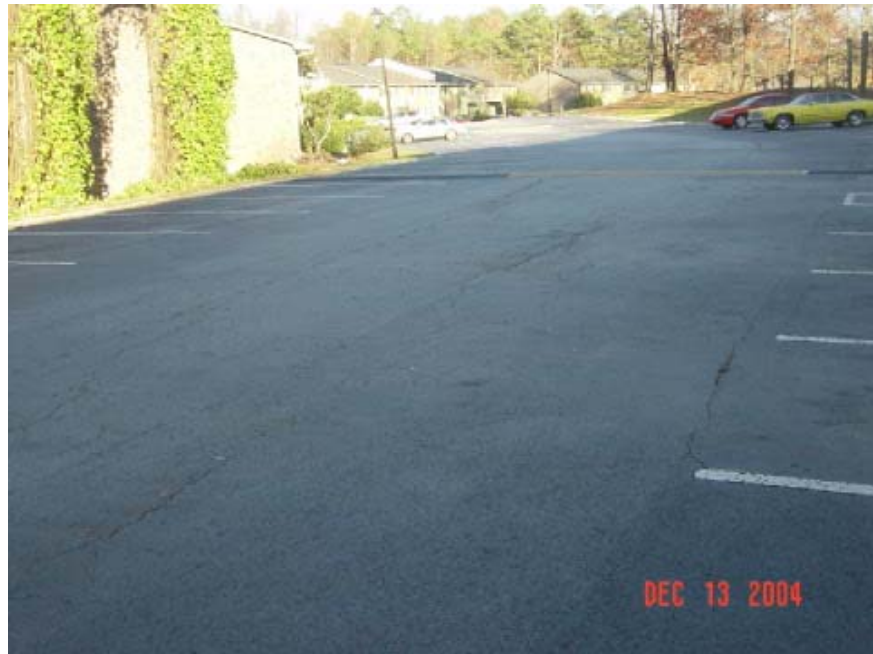
Asphalt paving is considered to be in a serviceable/fair condition. Patching, seal coating, and re-striping of the asphalt is recommended.

37. Typical asphalt drive area and condition.

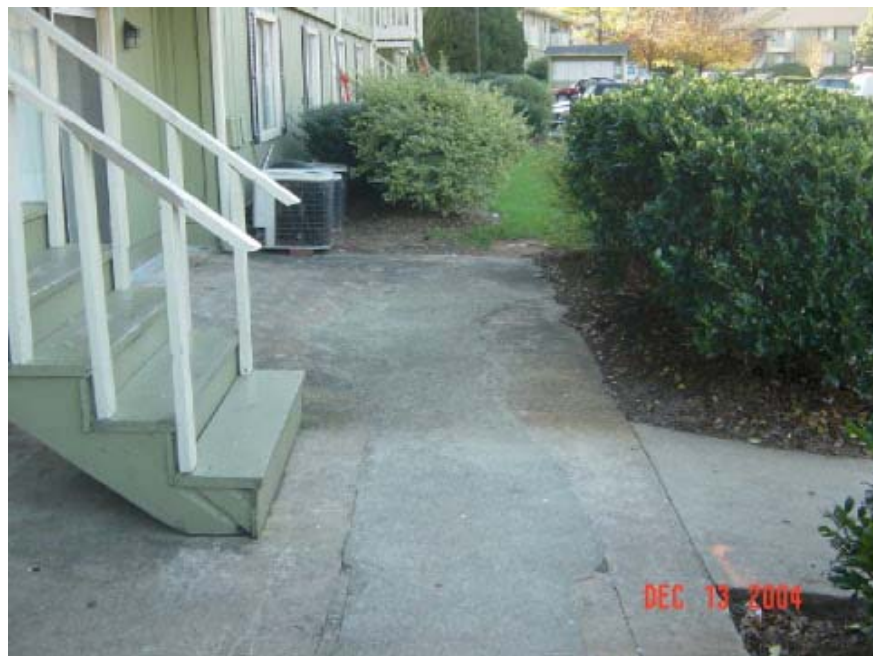
38. Damaged concrete at entry area to common hallway.

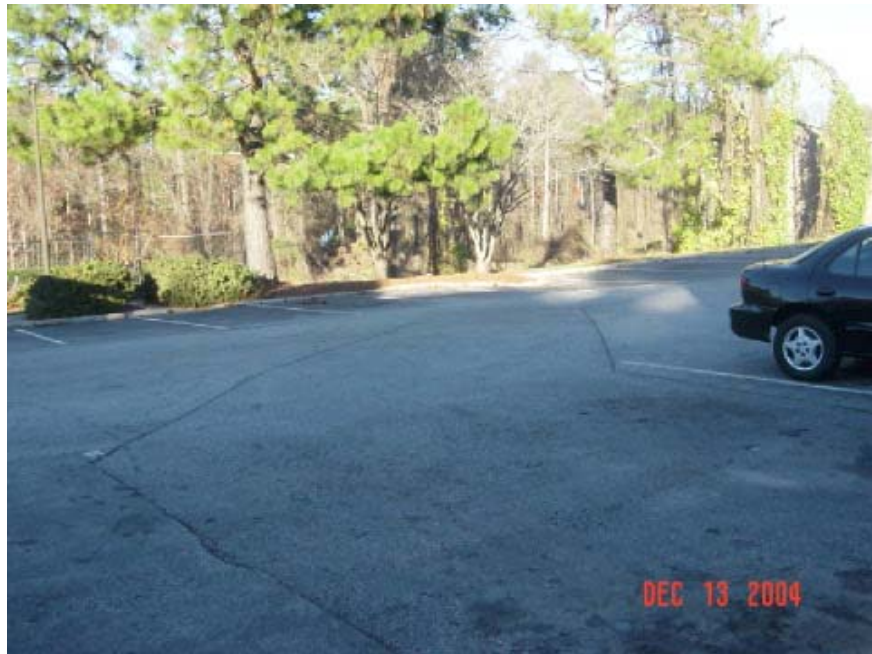
39. Asphalt damage due to tree roots – repair from previous problem.

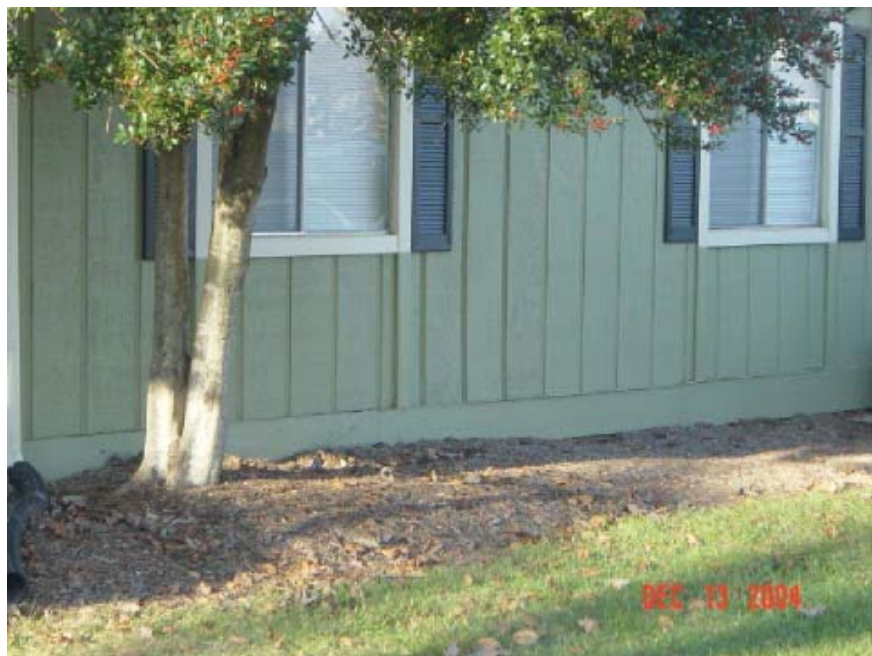
Termite infestation was noted to be a potential problem (some wood/ground contact) at the subject property (no evidence of damage in units was observed).

40. Wood/ground contact – potential for termite infestation.

We recommend that a termite inspection be conducted by a reputable pest control company.

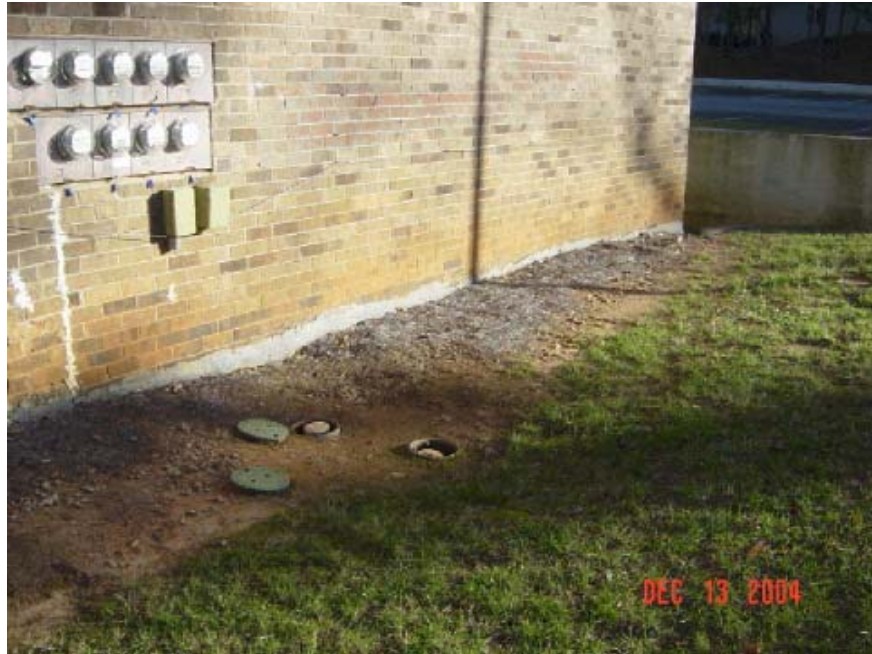
41. Waterproofing completed at the end elevation – condition at several buildings.

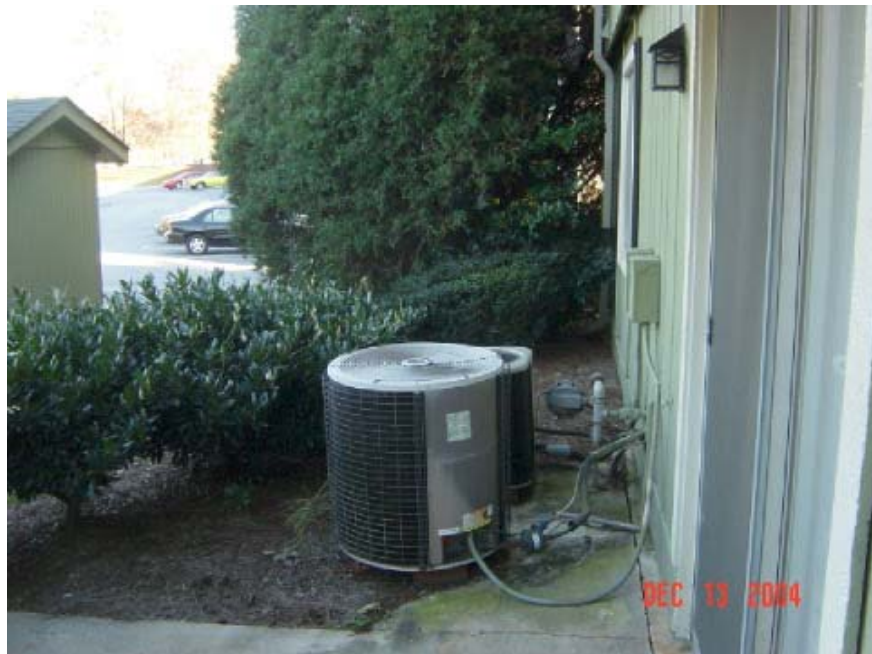
A majority of the HVAC air handling equipment was noted to be original with the exception of a few units. The condensing units vary in age and manufacturer with approximately 30% noted to be original equipment. The average life of the condensing units is 12 years. Equipment replacement and upgrade of the original equipment is recommended and is a part of the proposed renovation plan.

42. Typical HVAC condensing unit and location.
